Saginaw - Tittabawassee Rivers Contamination Community Advisory Group

CAG members see Segment 2 cleanup of the Tittabawassee River

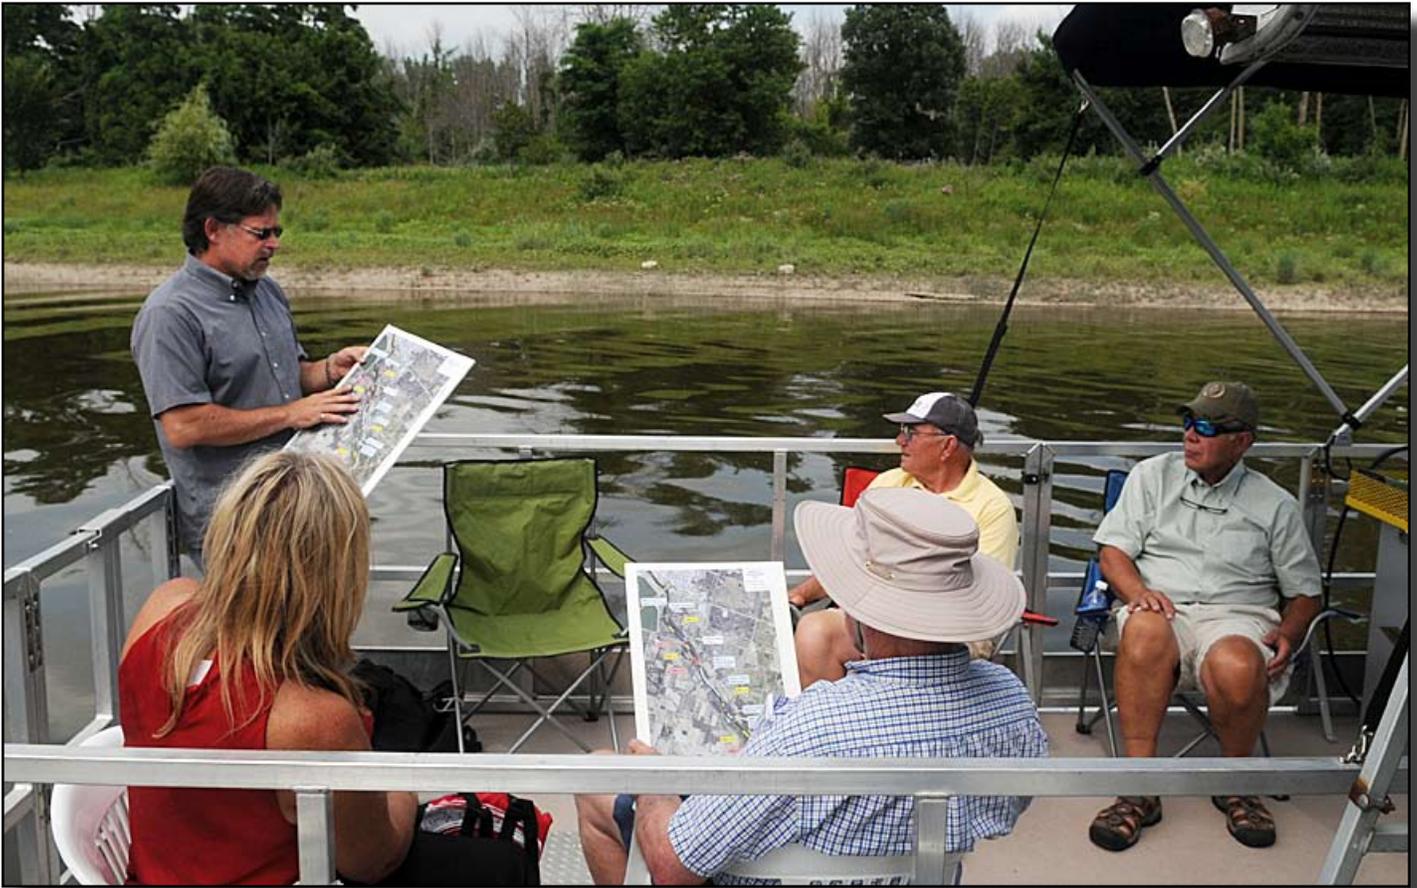
Todd Konechne, left, of the Dow Chemical Company explains some of the early work done along a bank of the Tittabawassee River to members of the CAG. The bank in the background was worked on a couple of years ago and is in the upper section of Segment 2. The area was seeded with native plants.

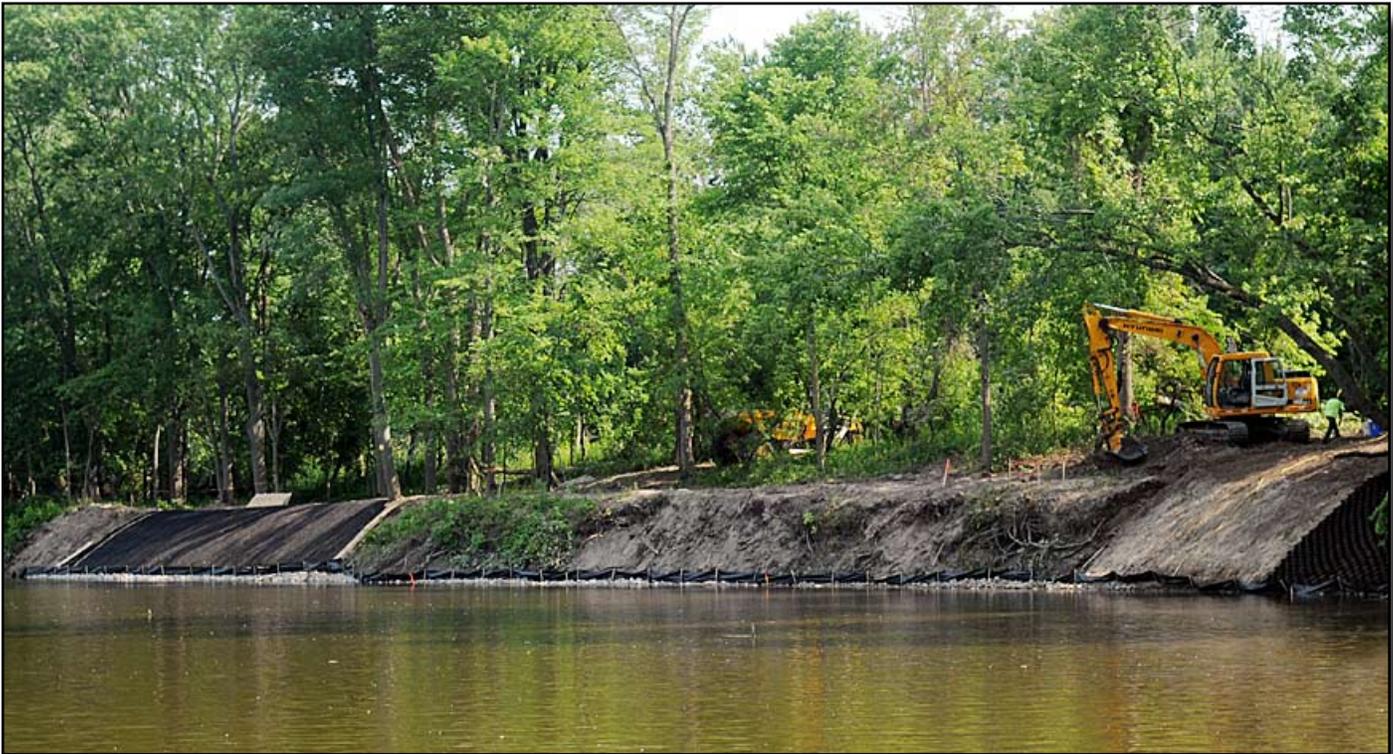
Below the group gets a look at a bank area undergoing work. In a few years it should look like the bank in the top photo.

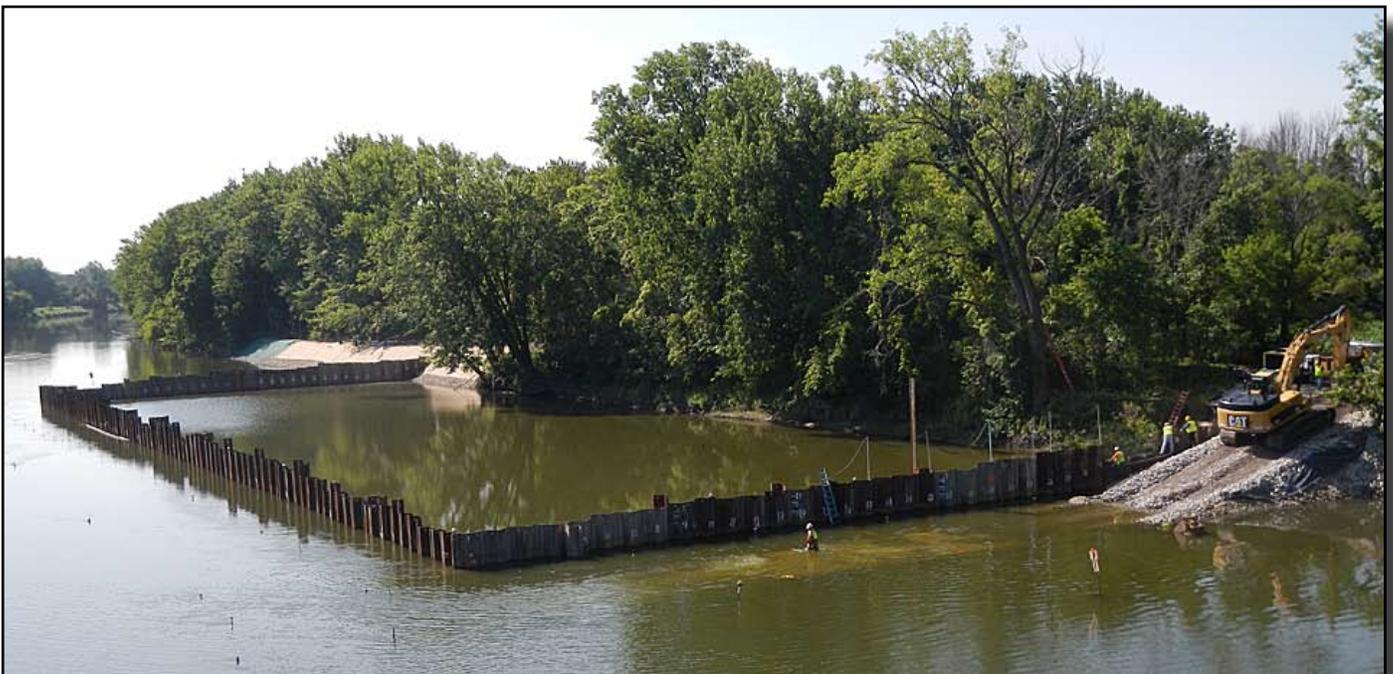
Photo above shows a bank area along the west side of the river, just downstream of the Gordonville Road bridge. Work on a dry dredging area was also underway. The Bank Management Areas (BMA) are areas where riverbank erosion could be a significant way for dioxin to get back into the river.

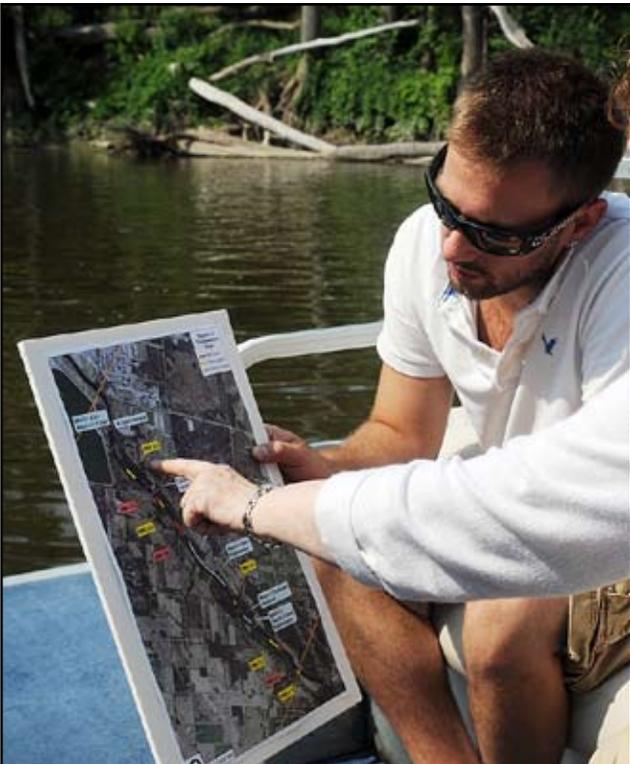
Maps of Segment Two were provided so those on the tour could get a good feeling for what the map shows and the actual site on the river.
